Post Earthquake Performance of Passive Fire Protection Systems

Author Peter Collier, Senior Fire Engineer, BRANZ Ltd

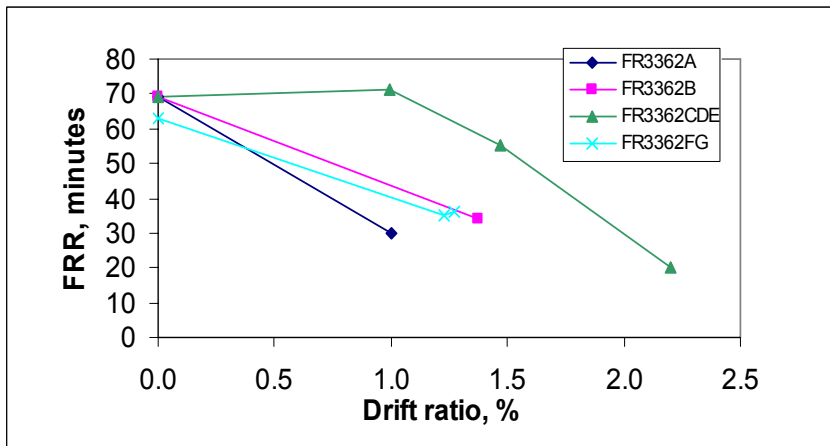
The Integrity component of fire resistance of the walls, where a failure is considered to be the appearance of flaming or hot gases on the ambient side, is compared with the drift ratio* in the above graph. A drift ratio of 1.5% corresponds with the design earthquake from the Loadings Code. The family of curves in the graph represent different edge details of the plasterboard and that had a major influence on the fixity of the plasterboard linings where detachment of the lining led to opening of gaps and flaming that ultimately resulted in Integrity failures.
